MARCH 1992

REPORT NO. 92-13

MIL-STD-1660 TESTS  
OF  
PLASTIC BOX PALLET

U.S. Army Defense Ammunition  
Center and School  
ATTN: SMCAC-DES  
Savanna, IL 61074-9639

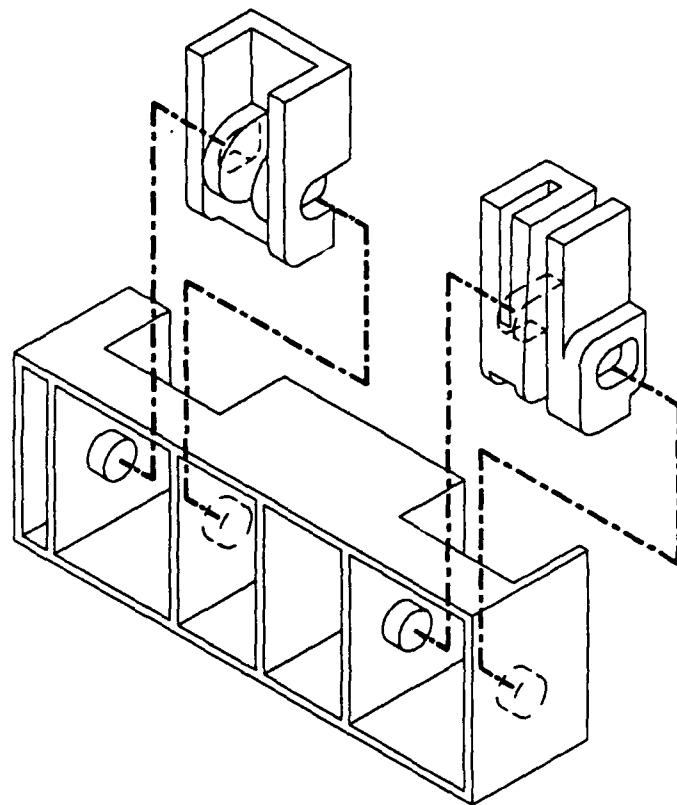
Figure 1. Hinge Detail

C. EDGEWISE ROTATIONAL DROP TEST. Each side of the pallet base was placed on a beam displacing it 4 1/2-inches above the floor. The ends of the pallet were raised to a height of 24 inches. The process was repeated in a clockwise direction until all four sides of the pallet had been tested. The first drop, to the right side, caused several hinges to break on the front and rear and a crack was evident through the pallet structure at the location of one of the hinges on the rear of the pallet. The third drop caused more hinges to break on the front and rear of the pallet. After the test was completed, 14 of the 16 hinges on the front and 10 of the 16 hinges on

the rear of the pallet were damaged; therefore, 8 out of 32 (or 25 percent) of the hinges were undamaged on the front and rear pallet walls. All of the hinges on the left and right sides remained intact. Therefore, only 40 of the 64 (or 62.5 percent) of the total number of hinges remained effective. The failure of such a large portion of the hinges was due to insufficient lateral strength of the pallet, allowing it to flex while the wall remained rigid; thus, the hinges yielded due to the excessive displacement of the wall of the pallet (see figure 1 below).

2. The addition of wooden or metal inserts under the pallet skids and posts would give the pallet more resistance to friction during repetitive shocks.
3. Increase the lateral strength of the pallet by increasing the amount of material at the hinge areas of the front and rear of the pallet to prevent lateral flexing.

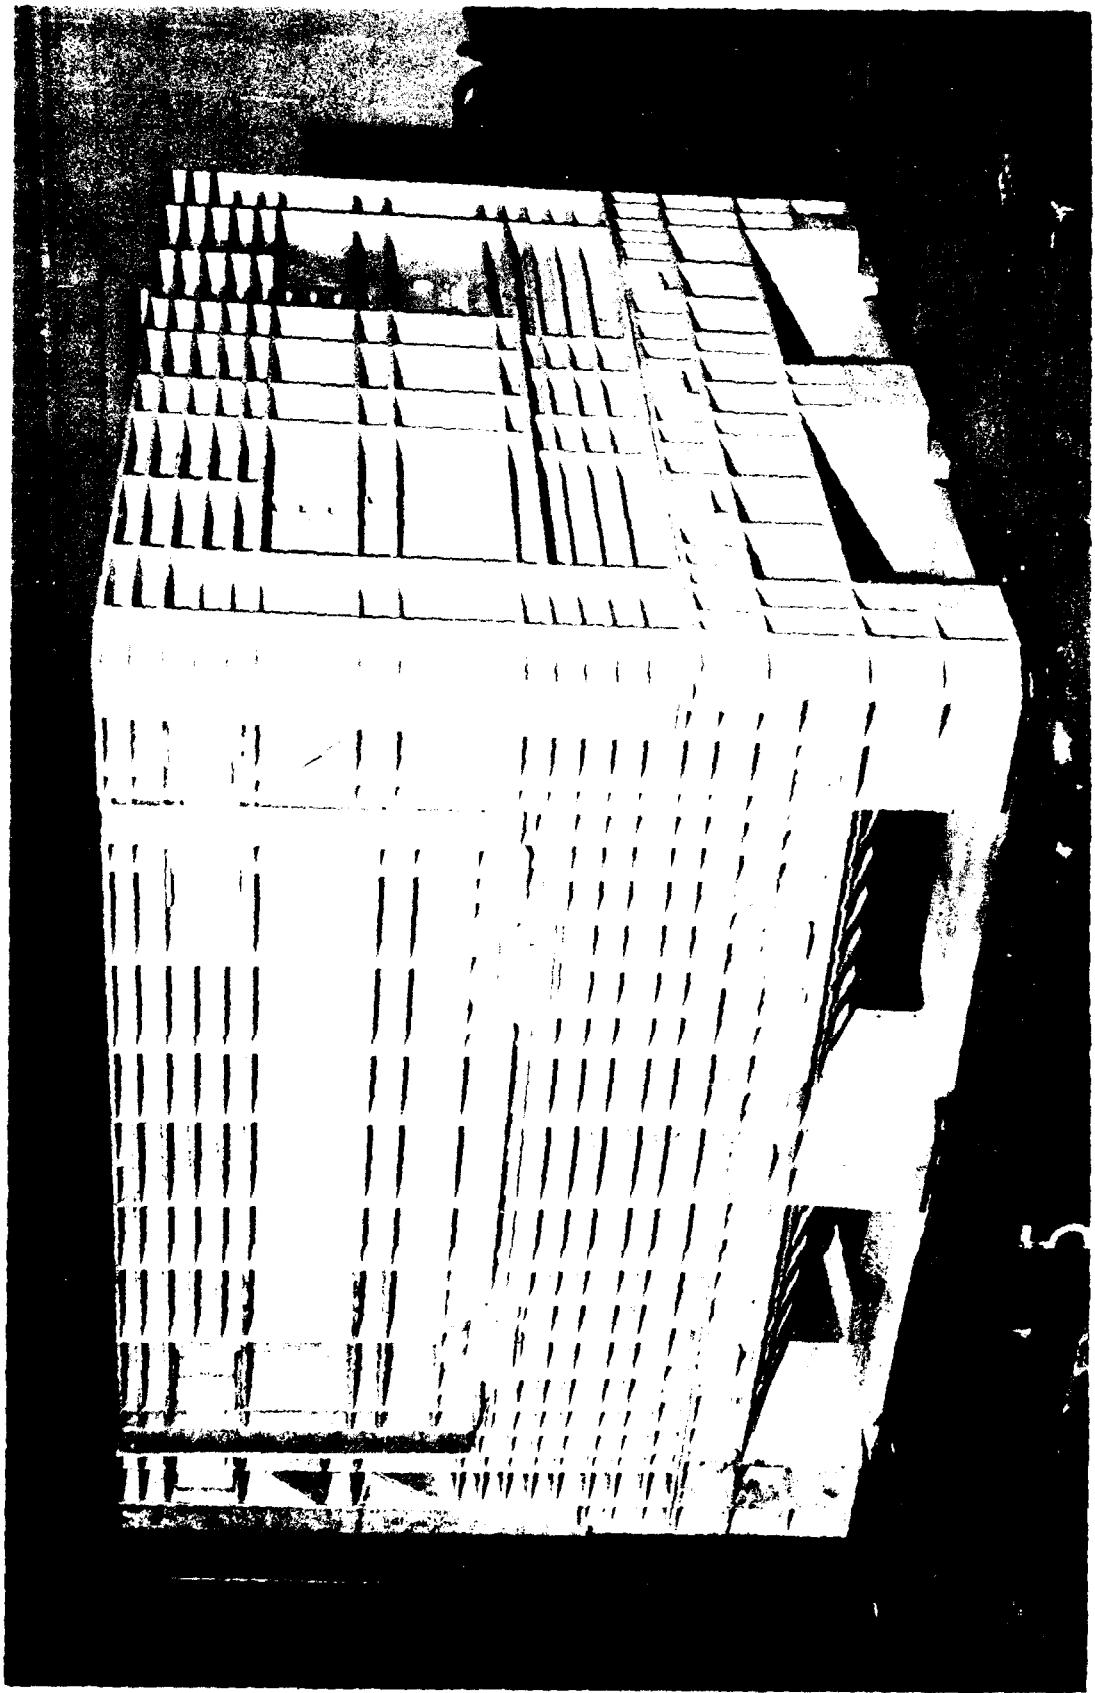
U.S. ARMY DEFENSE AMMUNITION CENTER AND SCHOOL - SAVANNA, IL	Photo No. AO317-SCN91-177-1531. This photo shows an overall view of the 2,500-pound capacity plastic box pallet.
--	--

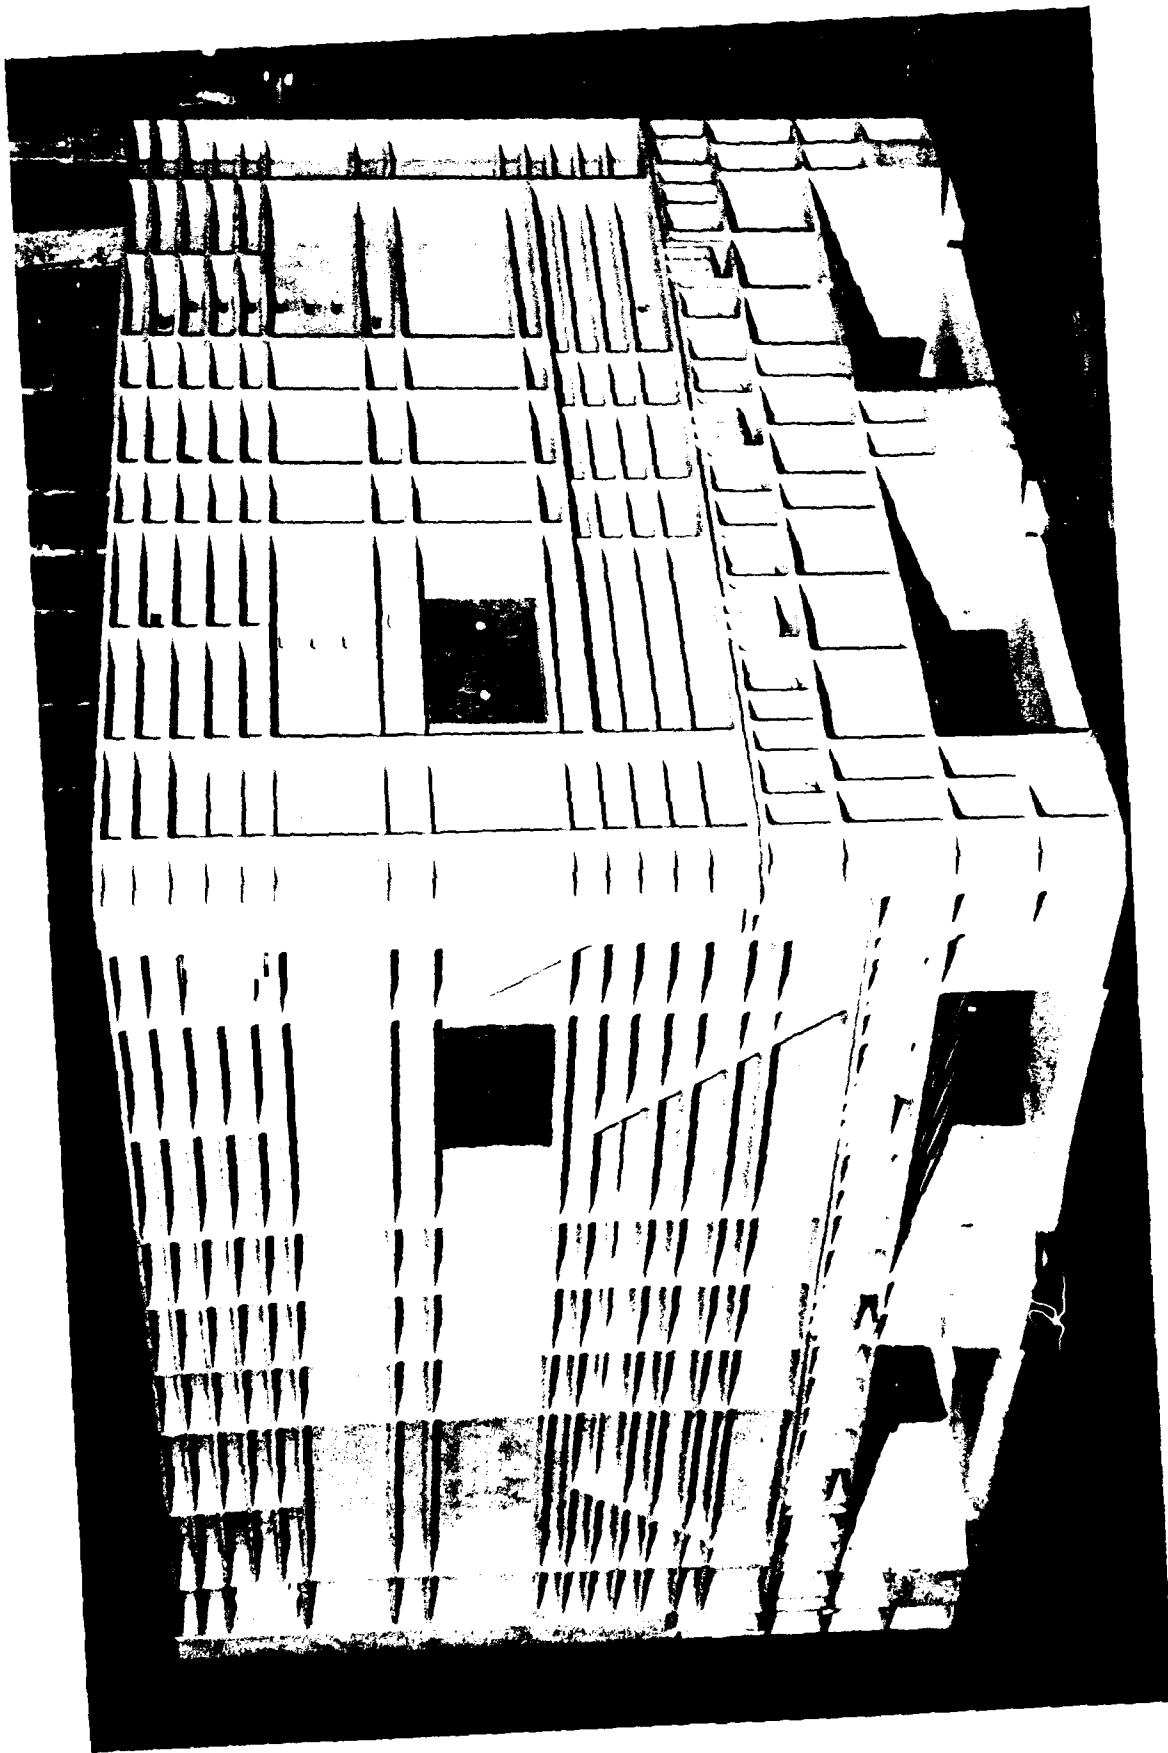
Photo No. AO317-SCN92-177-1524. This photo shows an overall view of the 2,500-pound capacity plastic box pallet.
